**R3 Inspections, LLC**  
**P.O. Box 152205**  
**Cape Coral, FL 33915**  
**Office: 239.810.7793**  
**Email: radjrsas@yahoo.com**

**Terrace I at Heritage Cove Association**  
**14121 Brant Point Circle, Fort Myers, FL 33919**  
**01-12-2012**

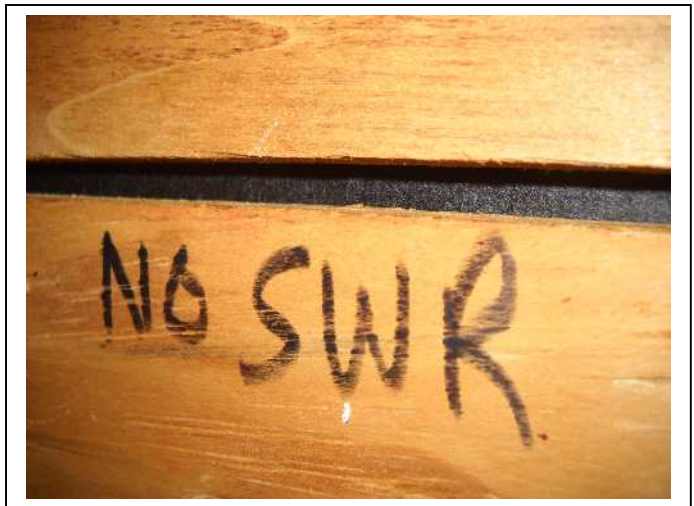
SECONDARY WATER BARRIER – Is not present.

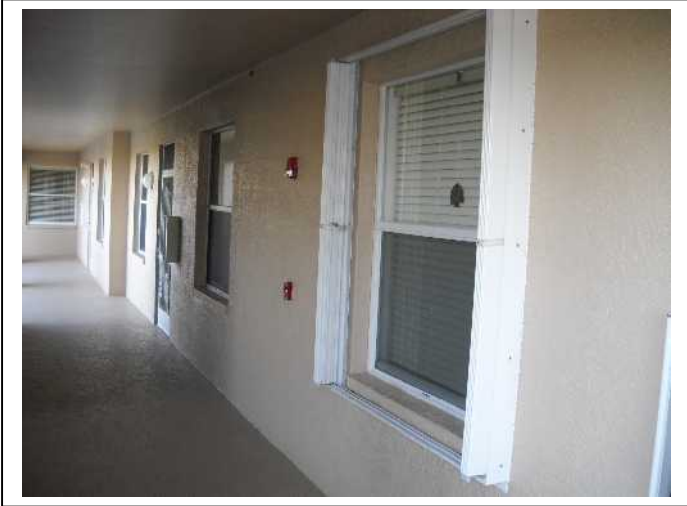
OPENING PROTECTION – Some of the glazed openings lack wind-borne debris protection.
